**Shades of Seattle
Fales Road Dump Site
Trip Report
Snohomish County, Washington**

TDD: 99-09-0007

TRIP REPORT

DATE: August 31, 2000
TO: Jeff Rodin, On-Scene Coordinator, EPA, Seattle, WA
FROM: Dave Byers, Project Manager, E & E, Seattle, WA
SUBJ: Shades of Seattle Paint Company, Fales Road Dump Site, Trip Report
REF: Contract No.: 68-W6-0008
TDD No.: 99-09-0007

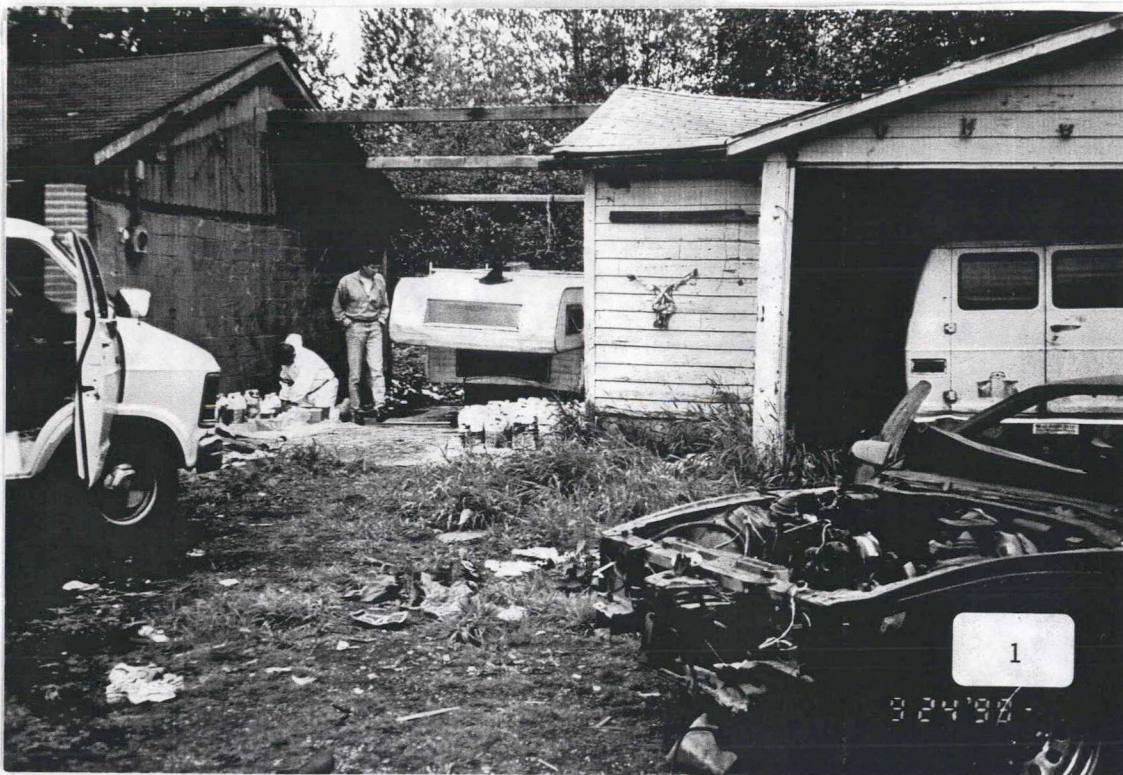
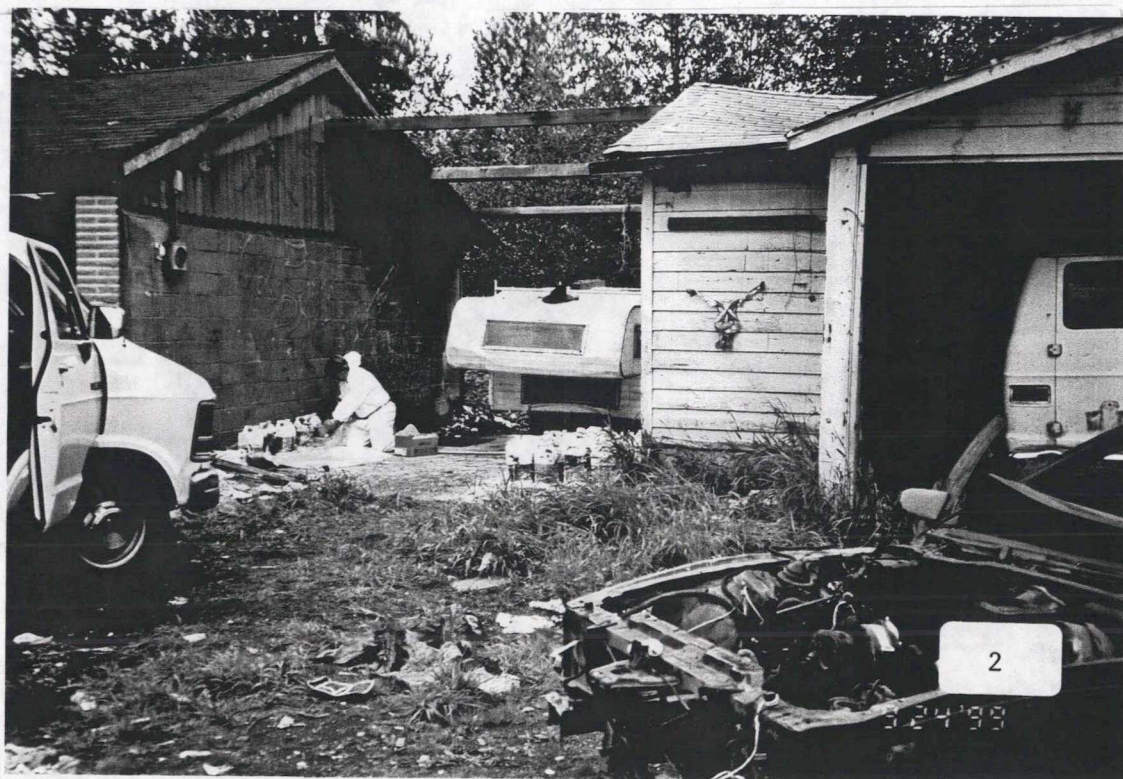
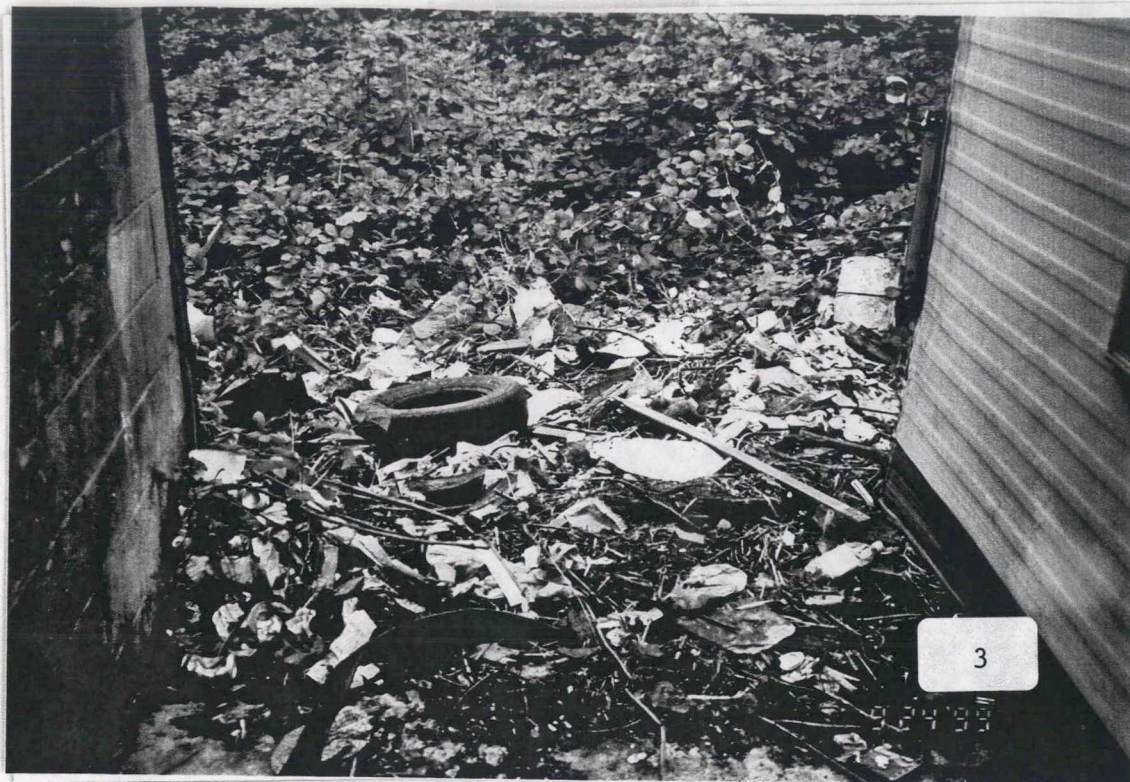
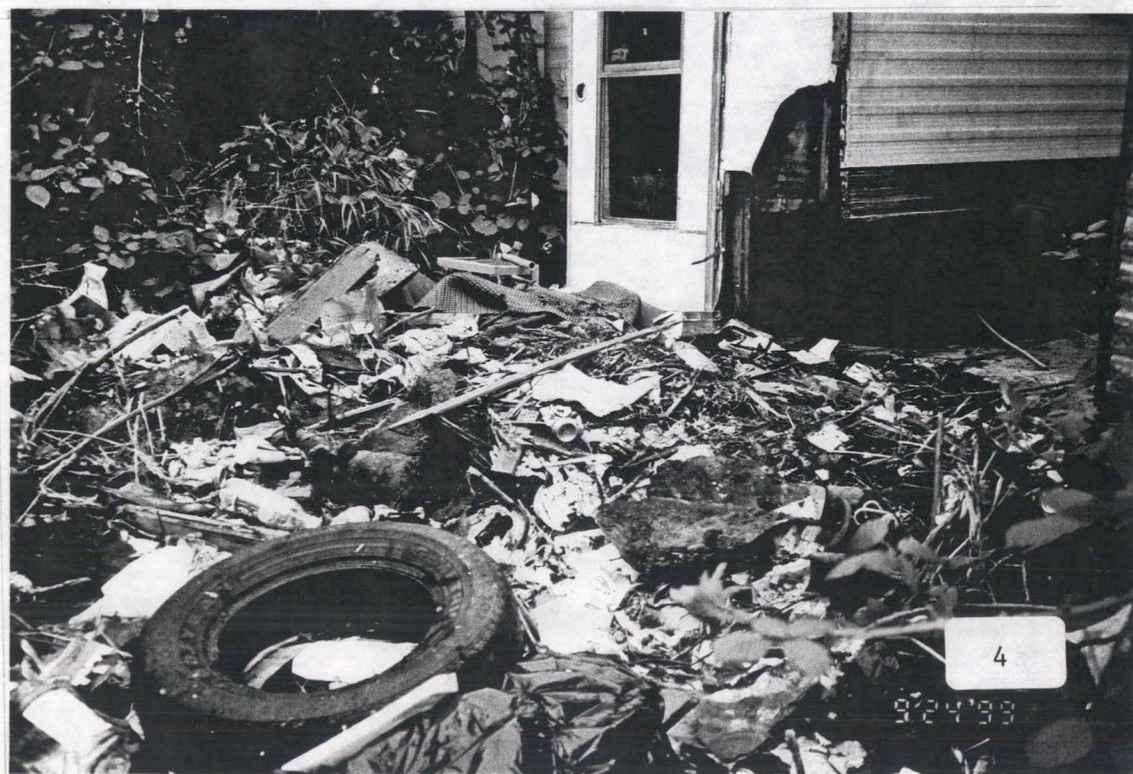
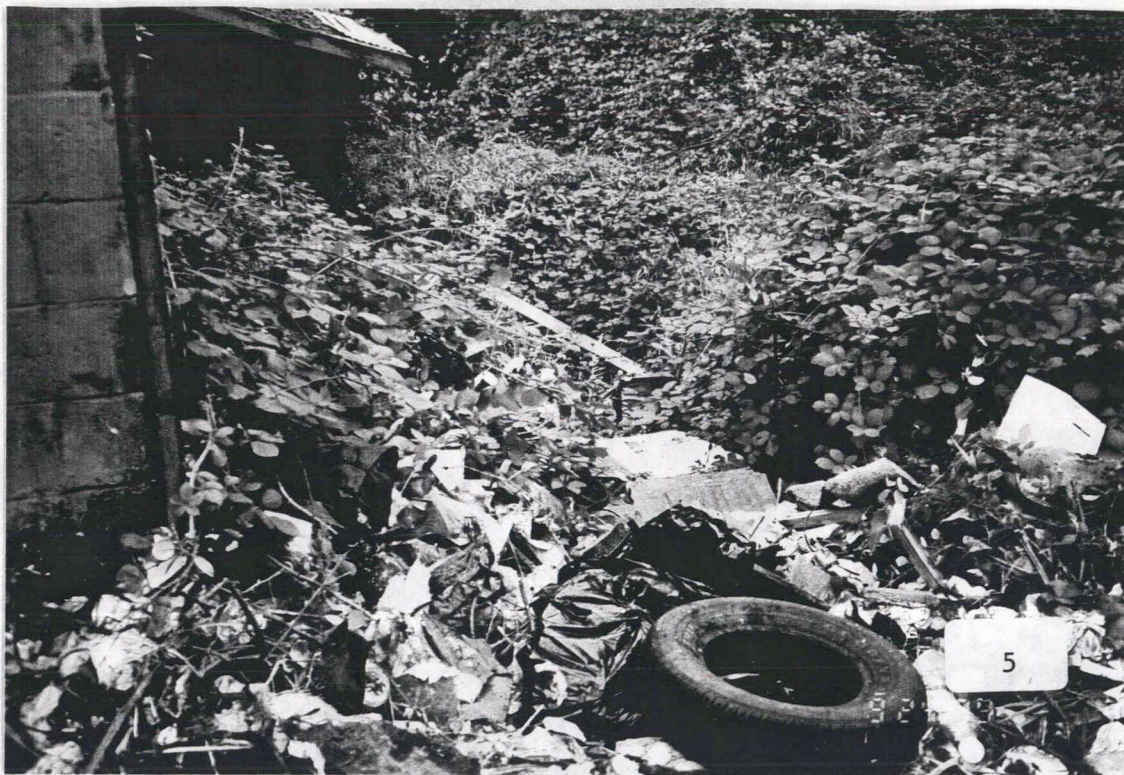
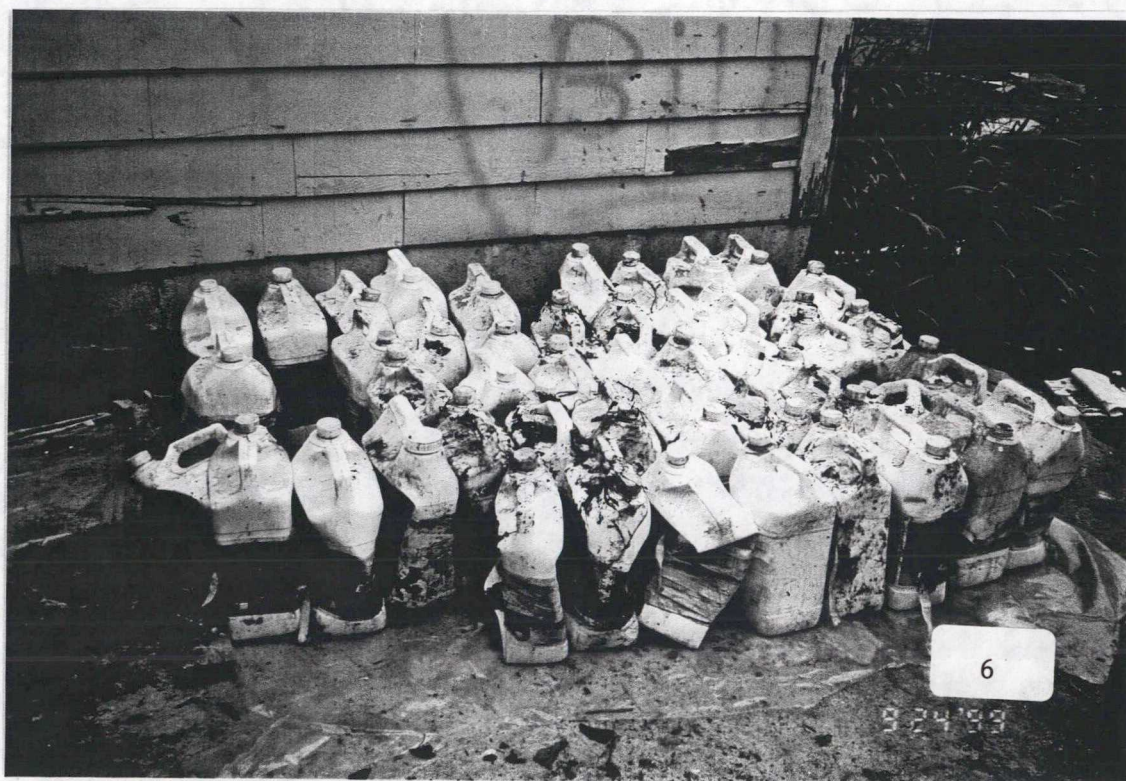
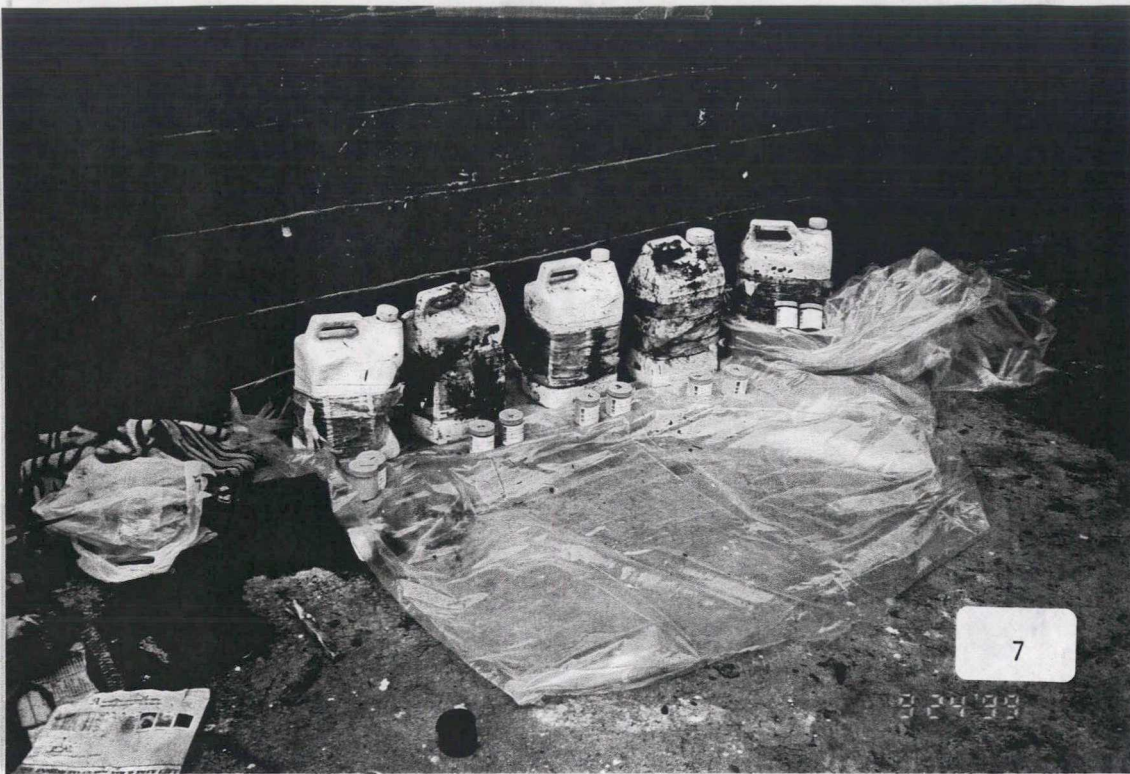
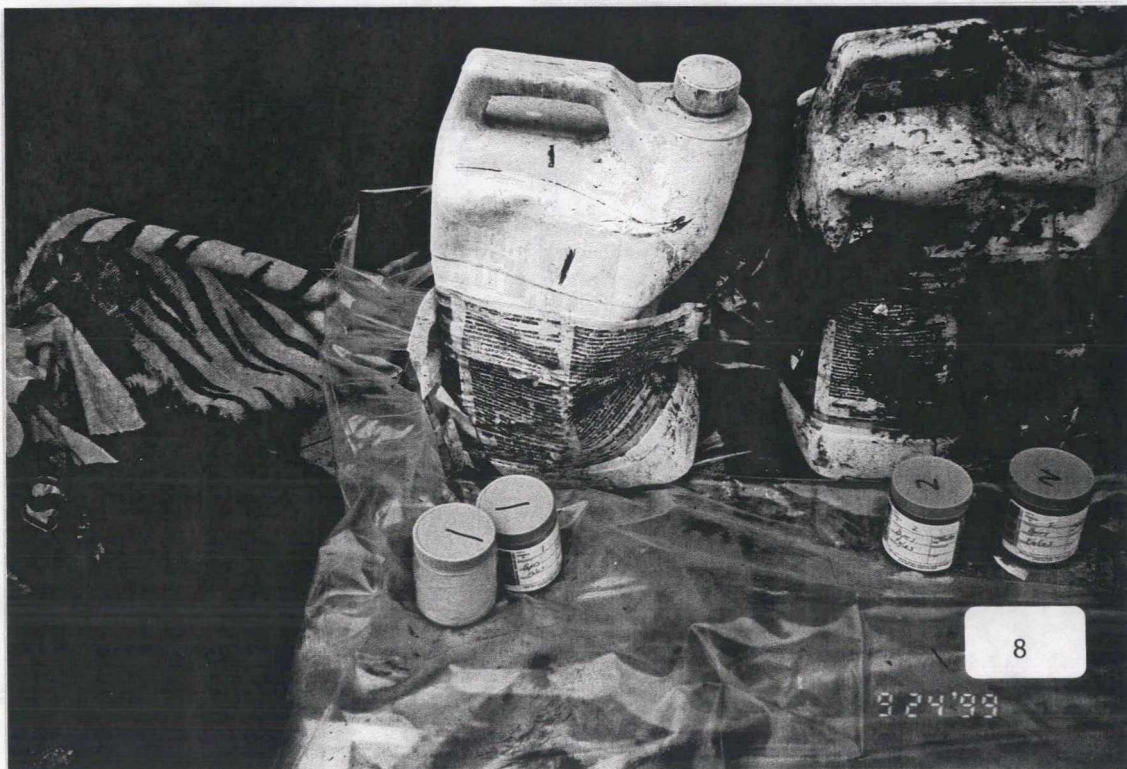
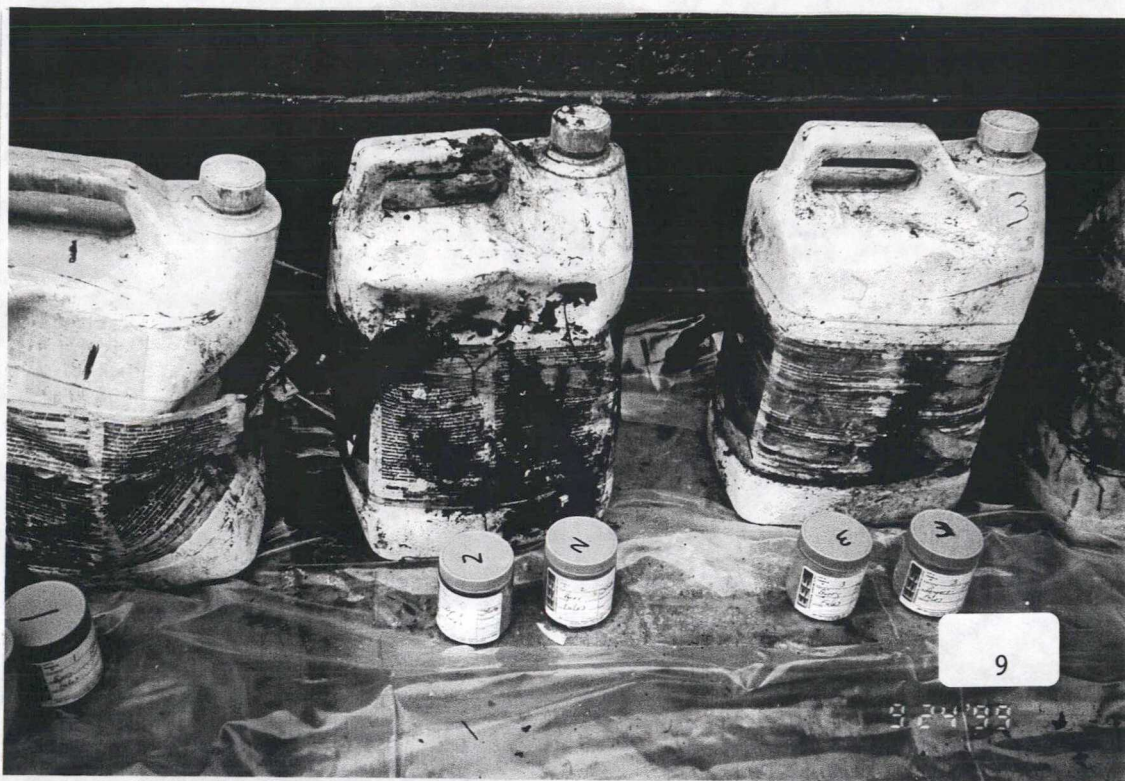
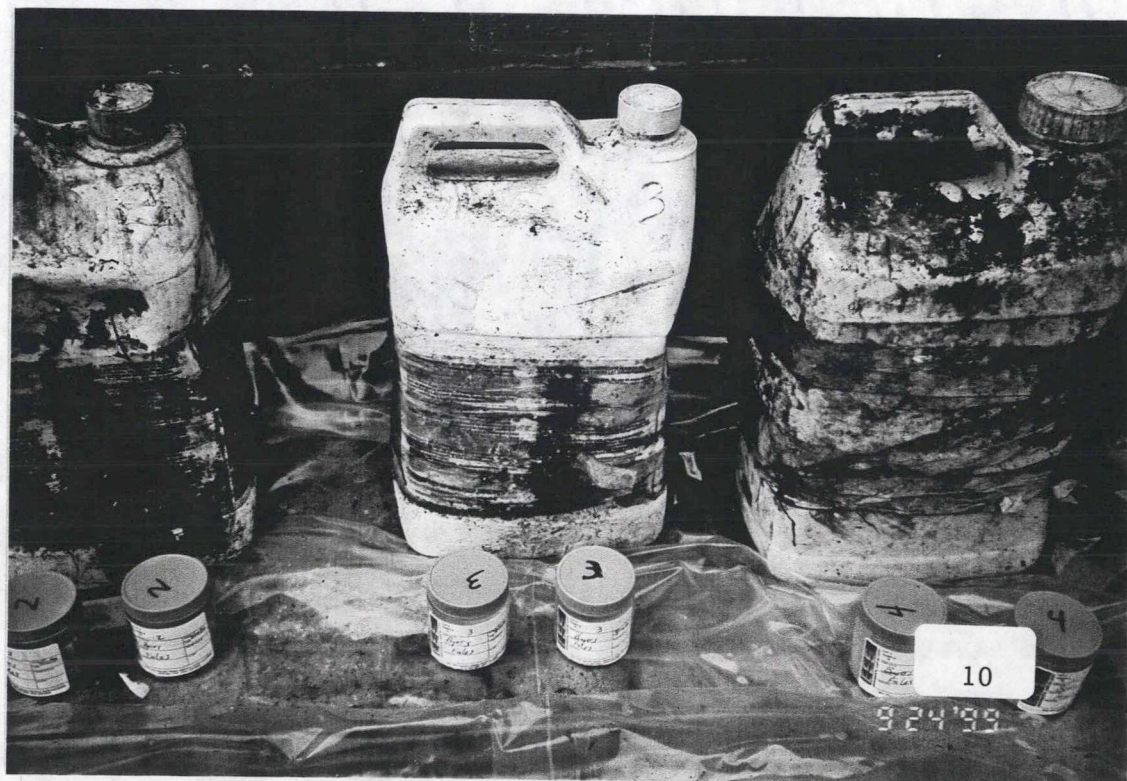
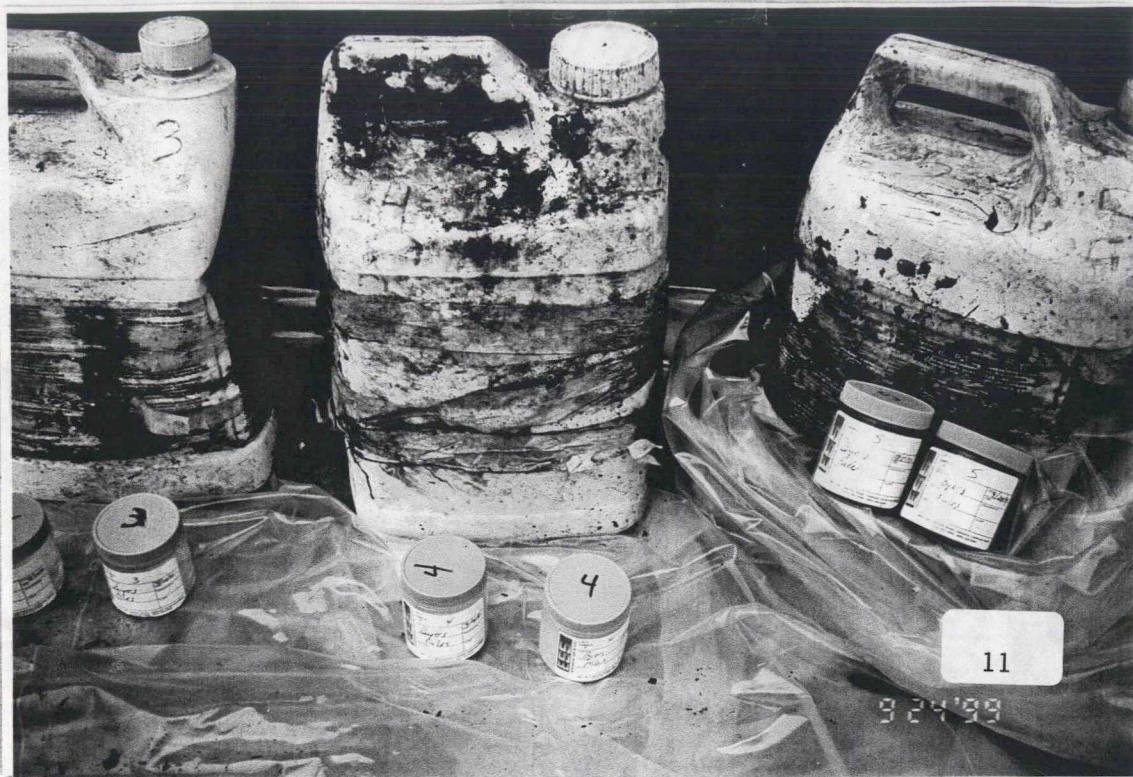
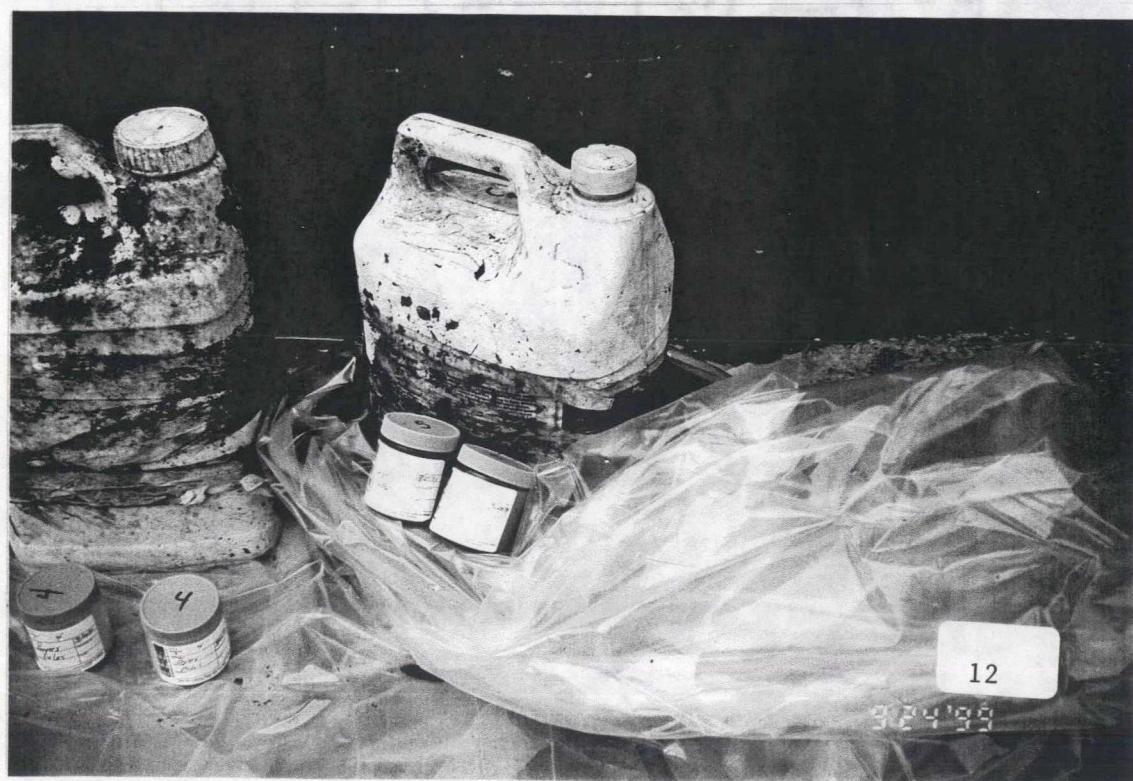
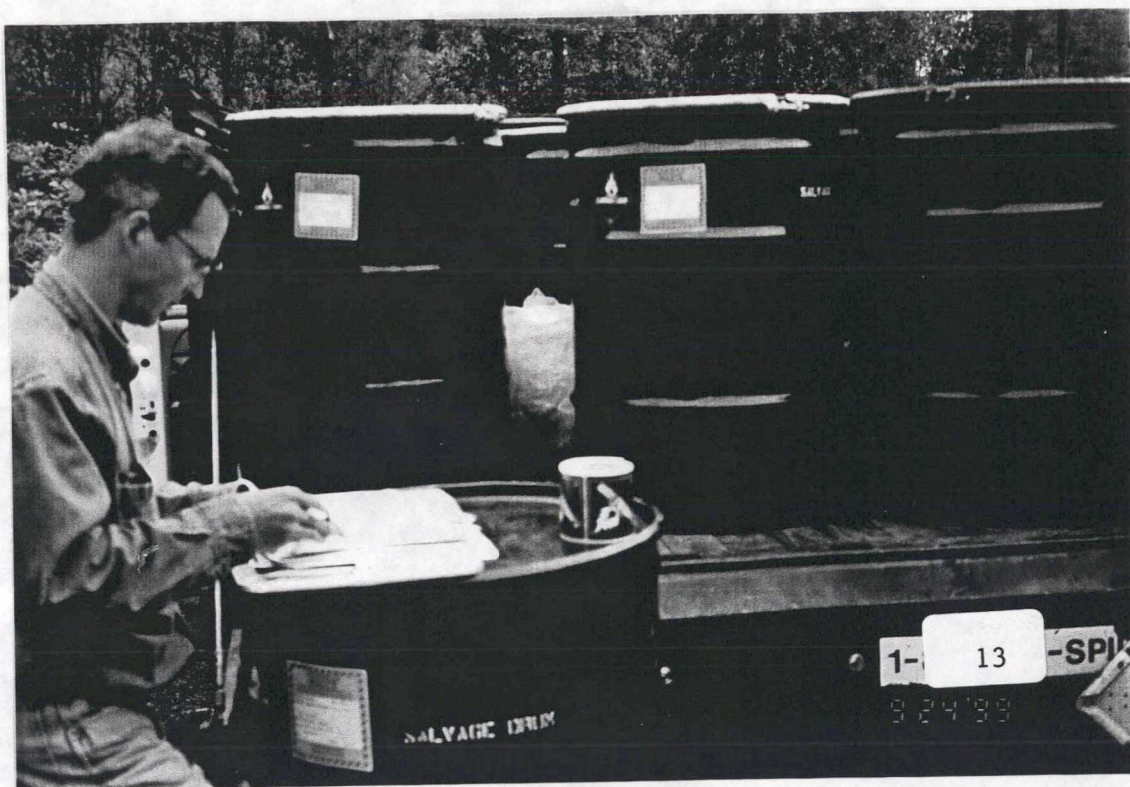
PHOTOGRAPH IDENTIFICATION SHEET

Photo	Date	By	Description
1	9/24/99	DB	The START sampling abandoned containers in staging area.
2	9/24/99	DB	Same as Photo 1.
3	9/24/99	DB	One of the dump areas where containers were found.
4	9/24/99	DB	Another dump area where containers were found.
5	9/24/99	DB	A third dump area where containers were found.
6	9/24/99	DB	All of the containers found at the site staged for transportation and disposal off site. Note the masking tape around several of the containers.
7	9/24/99	DB	An overview of the five samples collected by the START.
8	9/24/99	DB	Closer view of Sample 1.
9	9/24/99	DB	Closer view of Sample 2.
10	9/24/99	DB	Closer view of Sample 3.
11	9/24/99	DB	Closer view of Sample 4.
12	9/24/99	DB	Closer view of Sample 5.
13	9/24/99	DB	Foss Environmental preparing to transport paint-related waste off site for disposal.
